SUPPLEMENTAL REPORT ON HURRICANE OF SEPTEMBER 21, 1938,
AND ITS EFFECTS ON THE COASTAL REGION.

2. Purpose. - This report supplements a preliminary report submitted on November 12, 1938, in compliance with Division Circular Letter, dated September 23, 1938, File N.A.D. 32/308.1. Additional wind, barometric, tidal, and wave data, for the coastal region of this District, from Chatham, Massachusetts, to Greenwich, Connecticut, have been assembled. The correlation of the various phases of the storm and its effects has been studied. The purpose of this report is to present a more complete discussion of the relation of causes and effects of the hurricane upon the coastal region. The effects upon structures and the nature of failures have been briefly considered

United States Engineer Office
Providence, Rhode Island
June 17, 1939

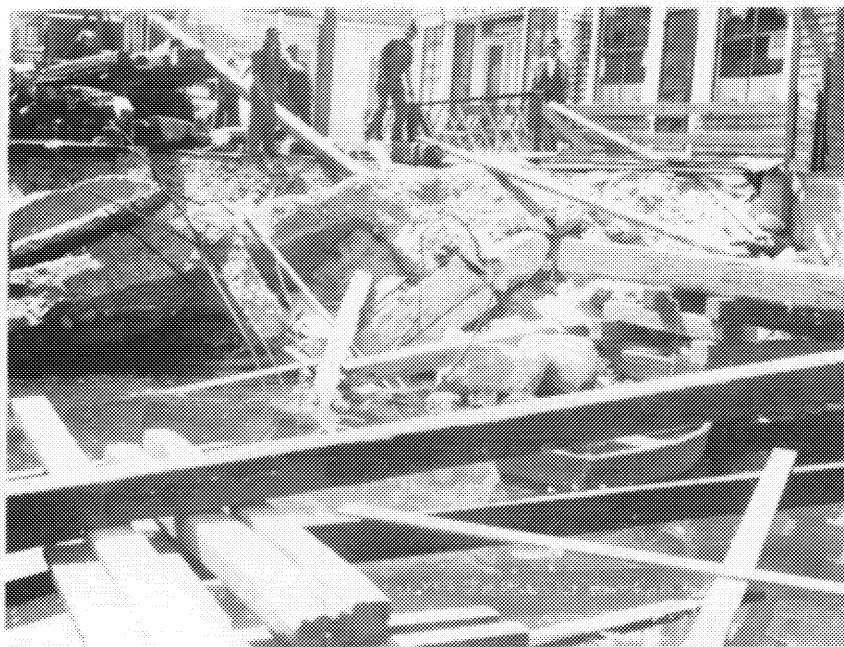
WOODS HOLE, MASS.
Damage to abutment
of bridge at
entrance to
Eel Pond.

26. Woods Hole, Massachusetts. - A low narrow barrier connecting Long Neck with the mainland was overtopped. Due to the greater height of the wave in Buzzards Bay than in Vineyard Sound the wash was from the north. A gully was scoured on the south side and some damage was done to the highway across the beach.

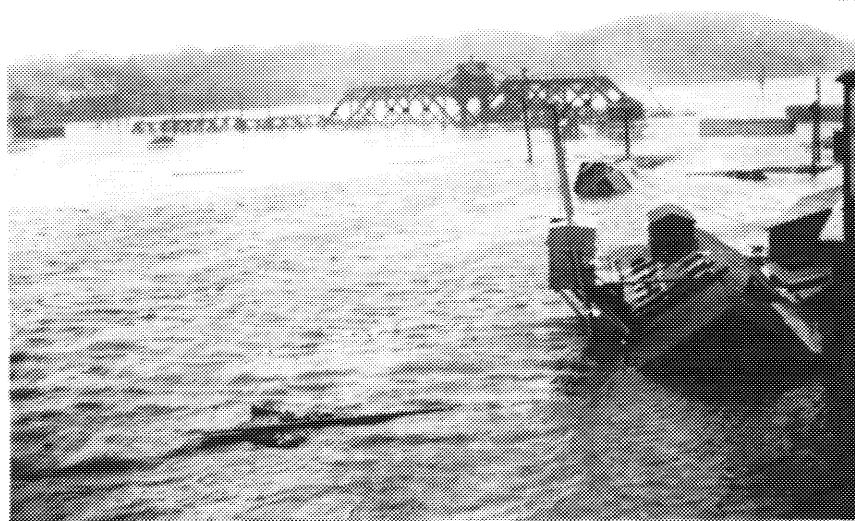
PROVIDENCE, R. I.
Flooded freight yard and sheds.

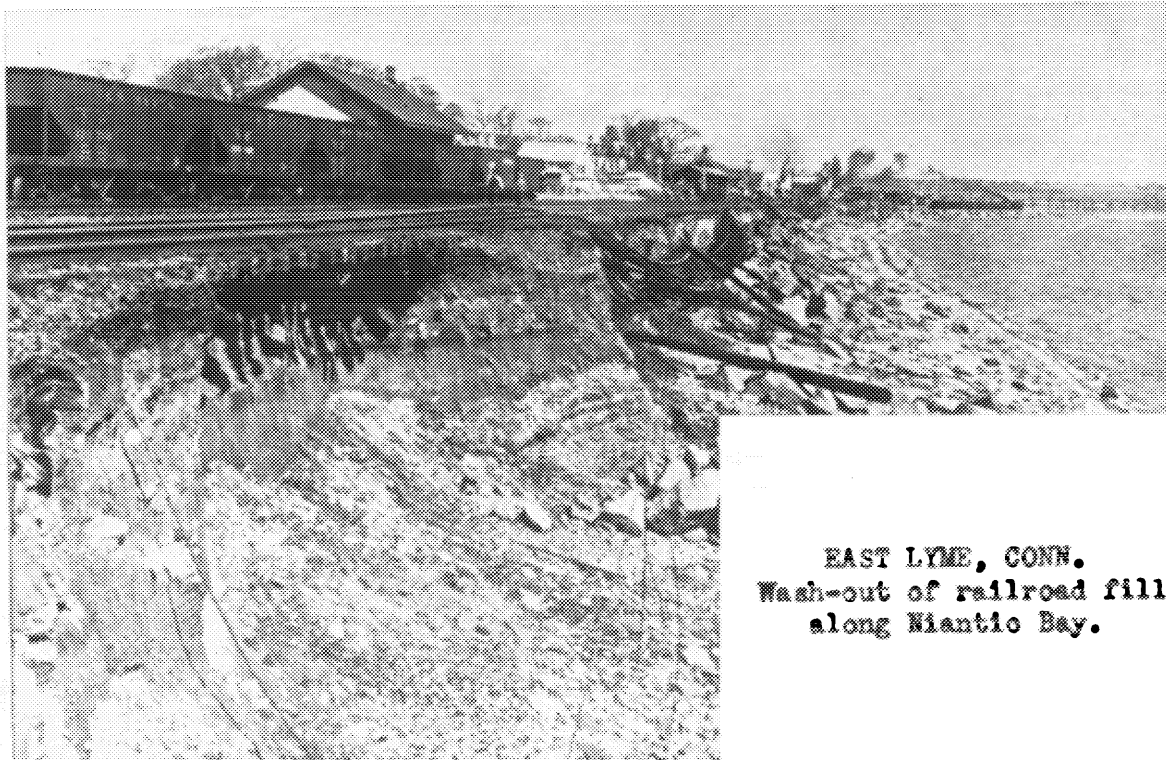
EAST LYME, CONN.
Wash-out of railroad fill
along Niantic Bay.

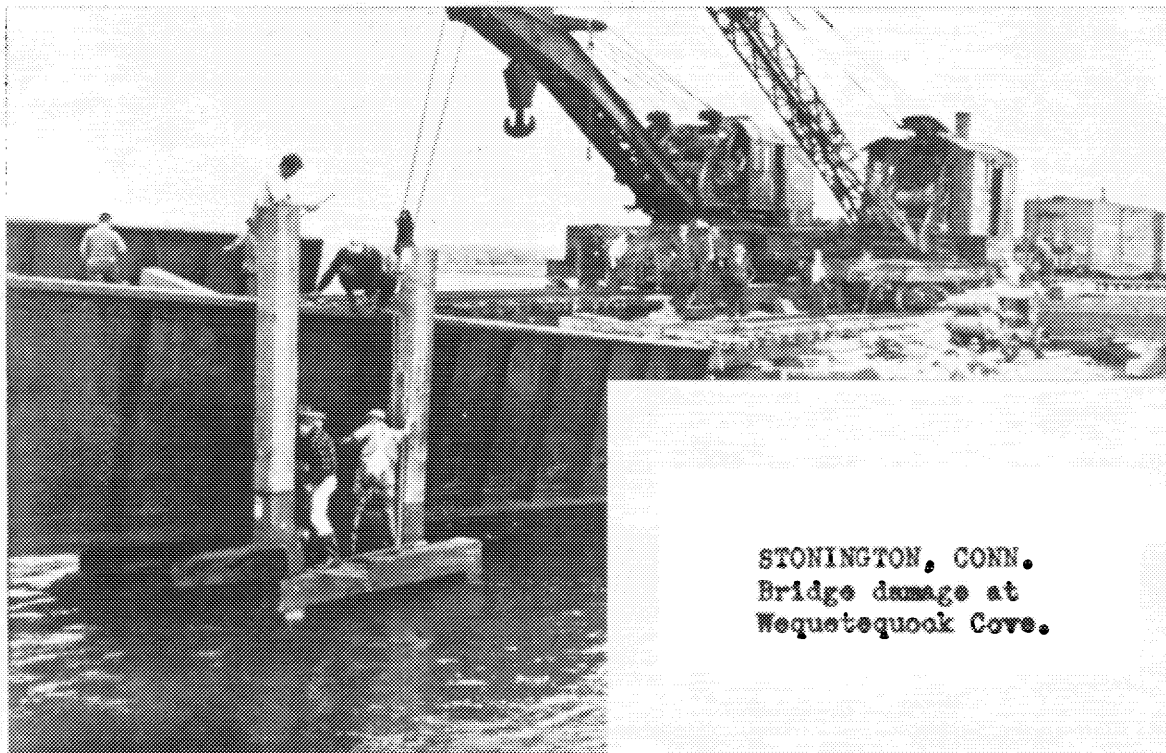
STONINGTON, CONN.
Bridge damage at
Wequetequock Cove.

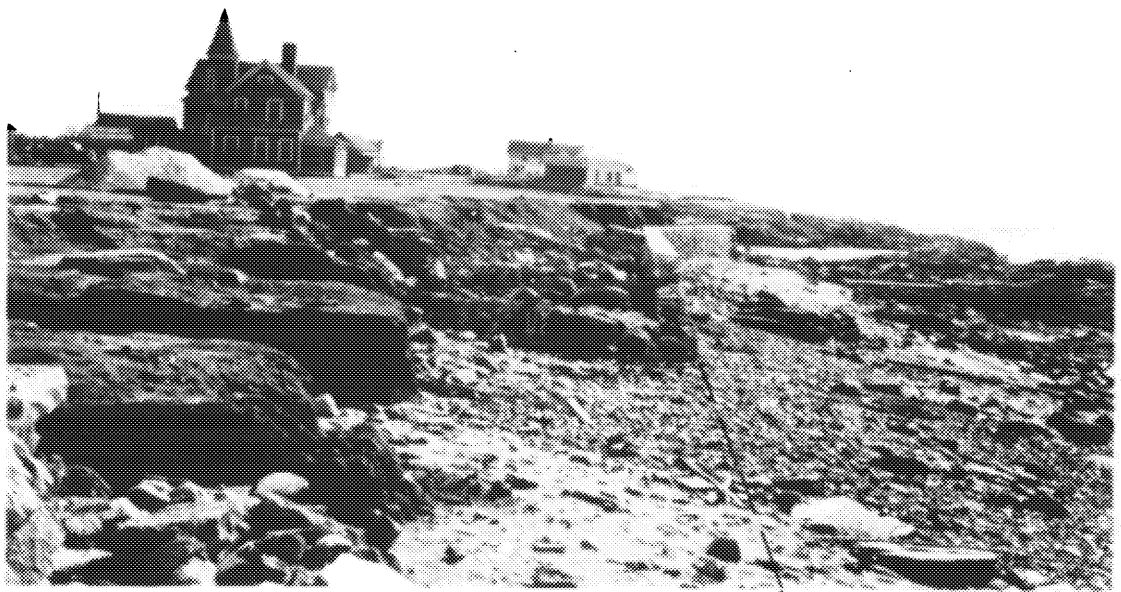
Broken seawall

SAKONNET POINT, R. I. Headland erosion and seawall destruction.

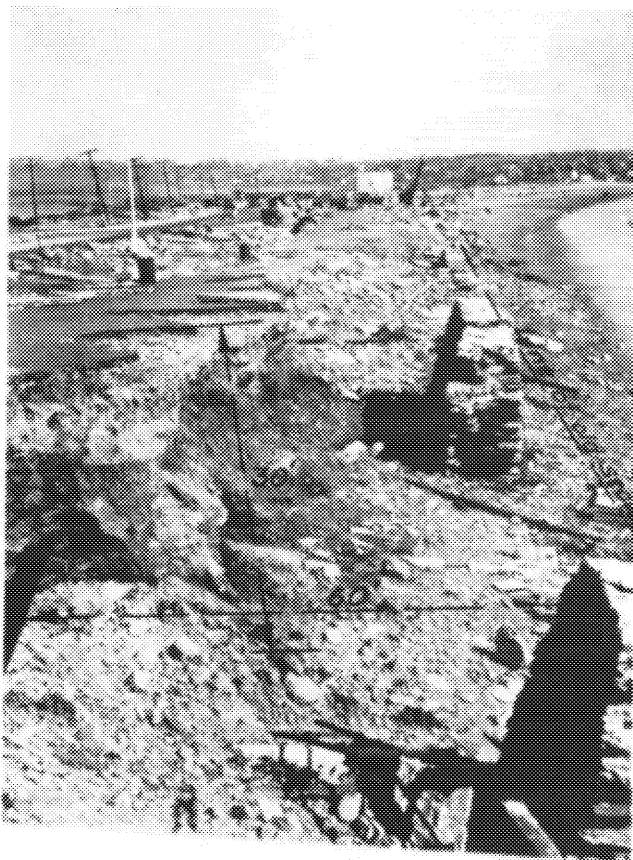
NEWPORT BEACH, R. I.
Headland erosion and
seawall destruction.

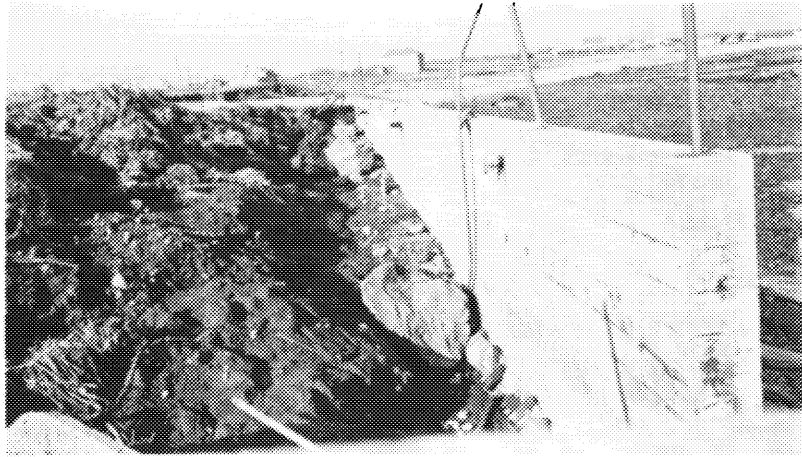
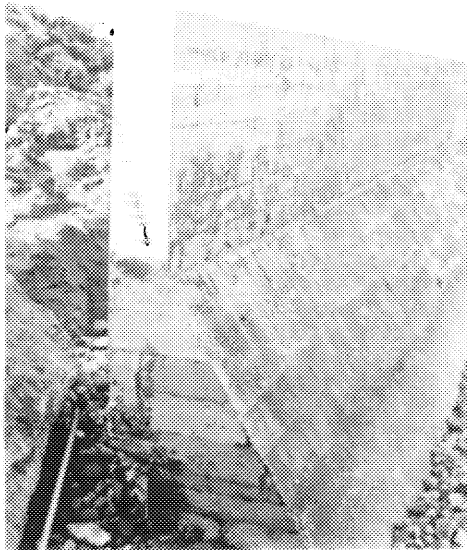
NARRAGANSETT, R. I.
 North of Point Judith
 Upper: Erosion behind
 seawall.
 Lower: Section of un-
 damaged seawall.

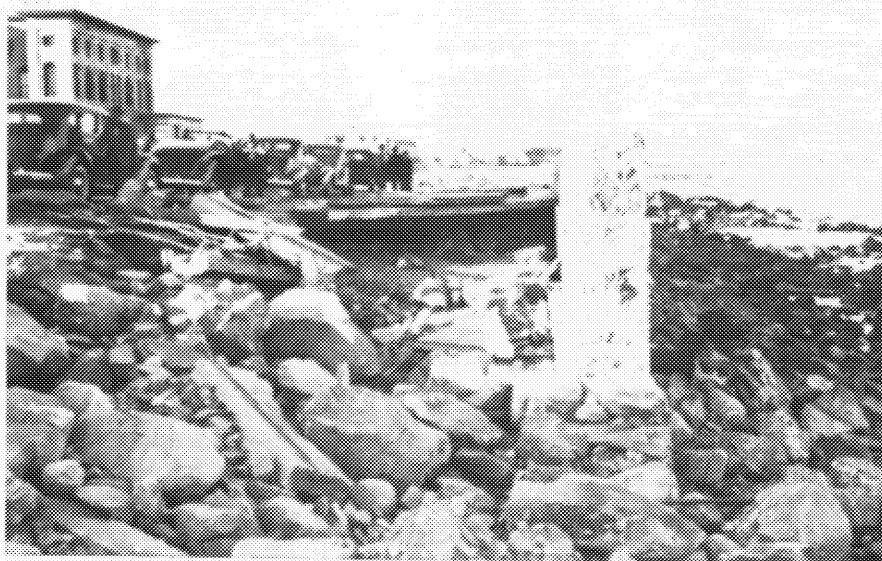
NARRAGANSETT PIER, R. I.
Headland erosion; seawall and highway destruction.

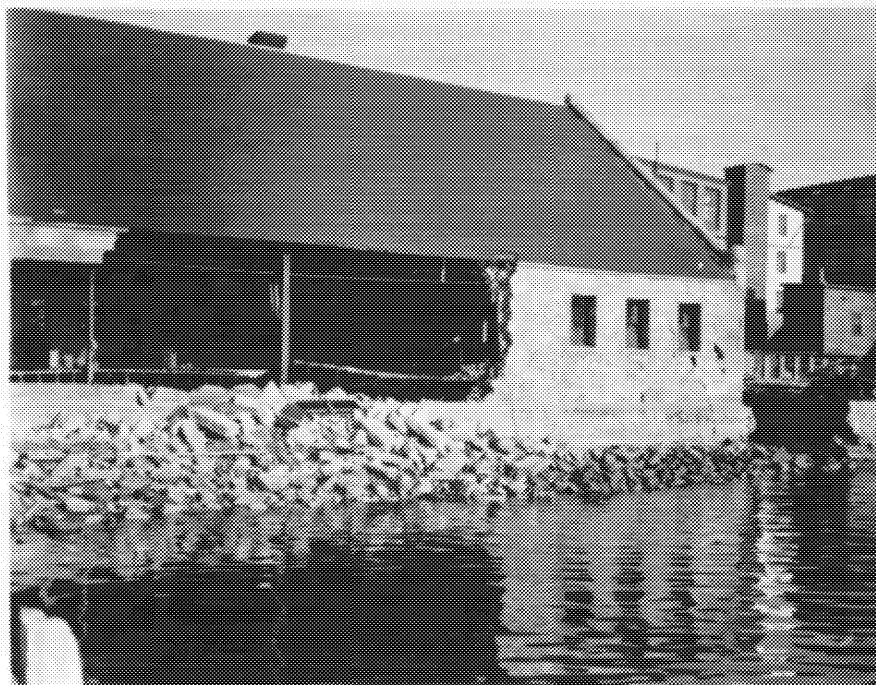
BRISTOL, R. I.
Substantial stone wall of Armory torn away
by wave and floating debris.

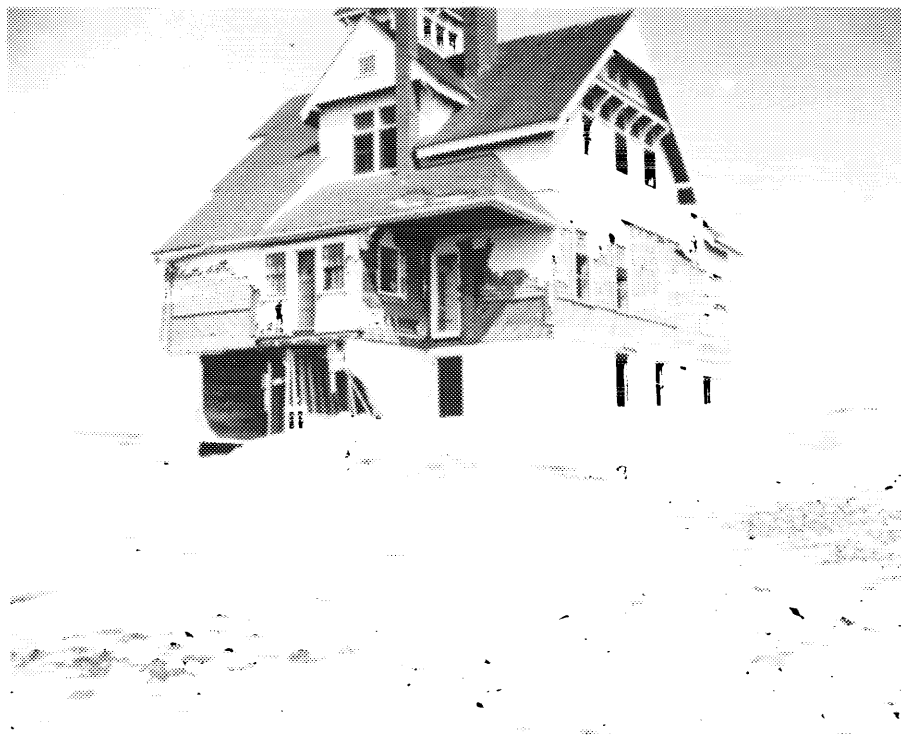
NEWPORT, R. I.
Damage to Brenton Point Coast Guard building
on Price Neck.

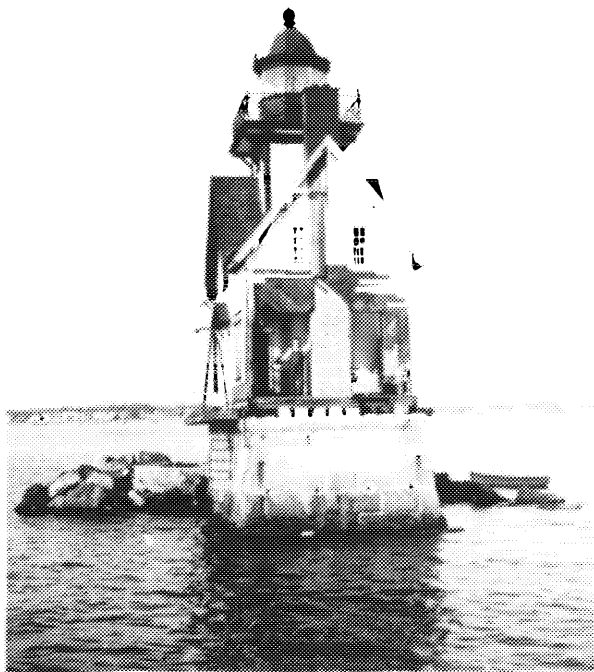
PROVIDENCE RIVER, R. I.
Bullock Point Light.
Wall of building torn
away by seas.

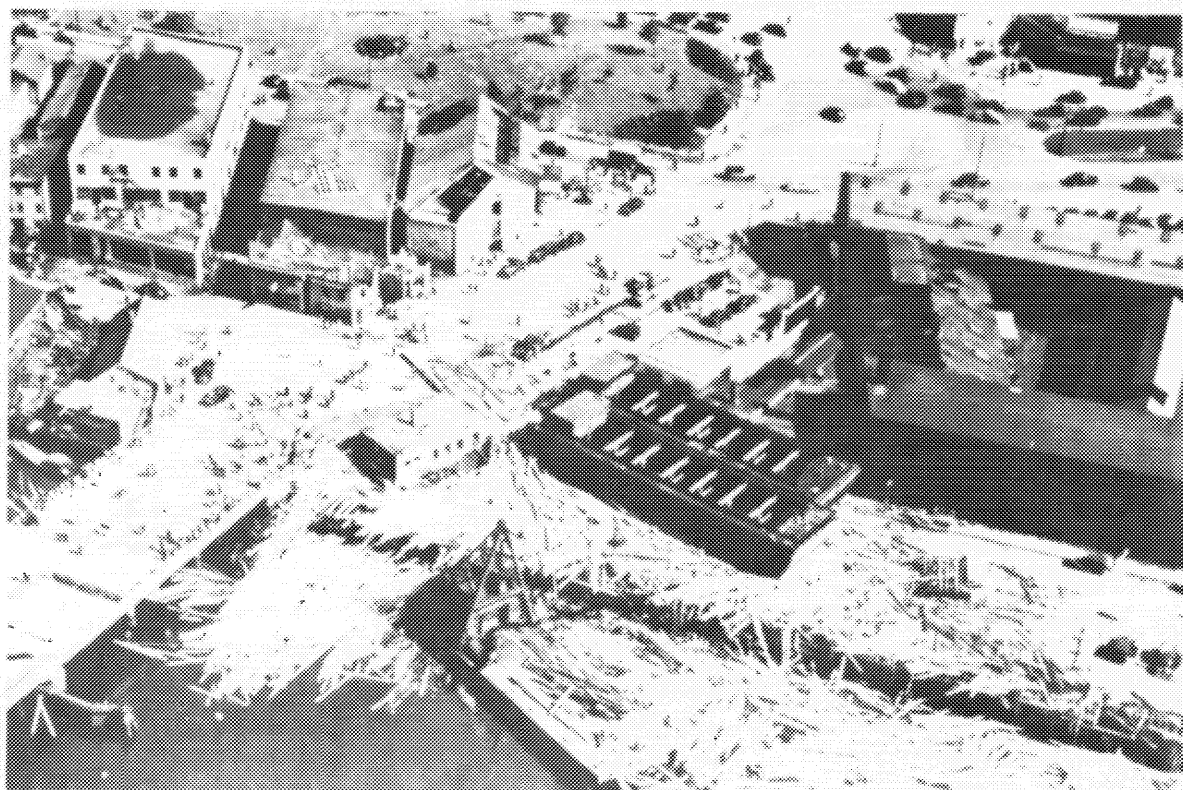
PROVIDENCE, R. I. Coal barges landed in South Water Street near Point Street Bridge. Lumber floated away from yards.

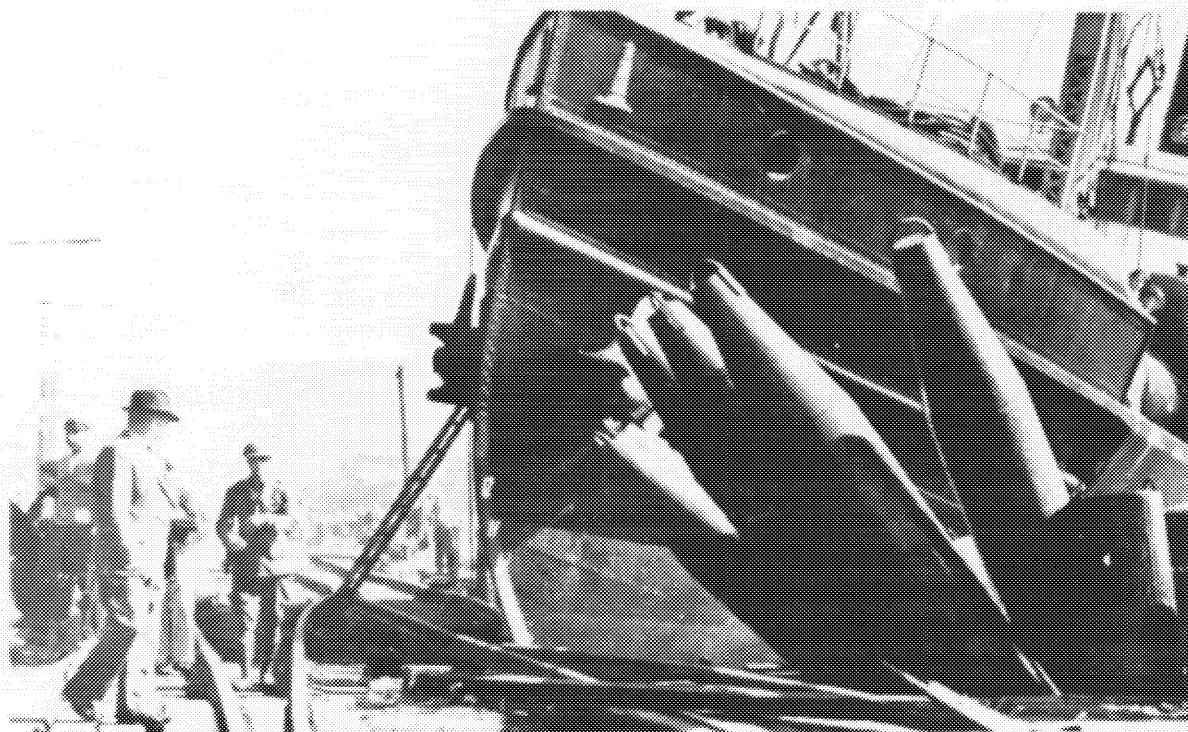
NEW LONDON, CONN.
Lighthouse tender TULIP out into railroad tracks.

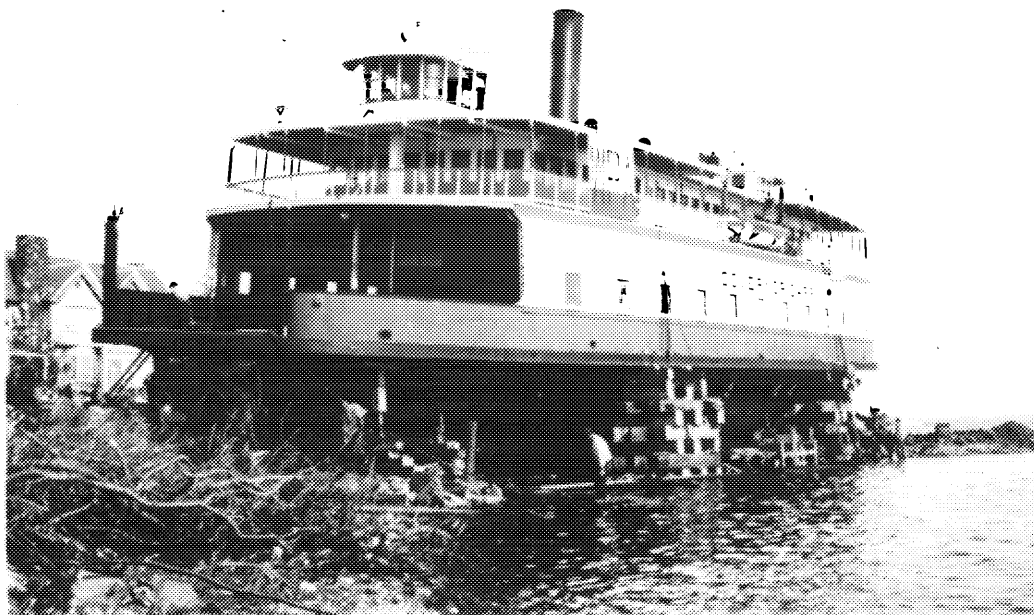
JAMESTOWN, R. I. Ferry GOVERNOR CARL carrying car.

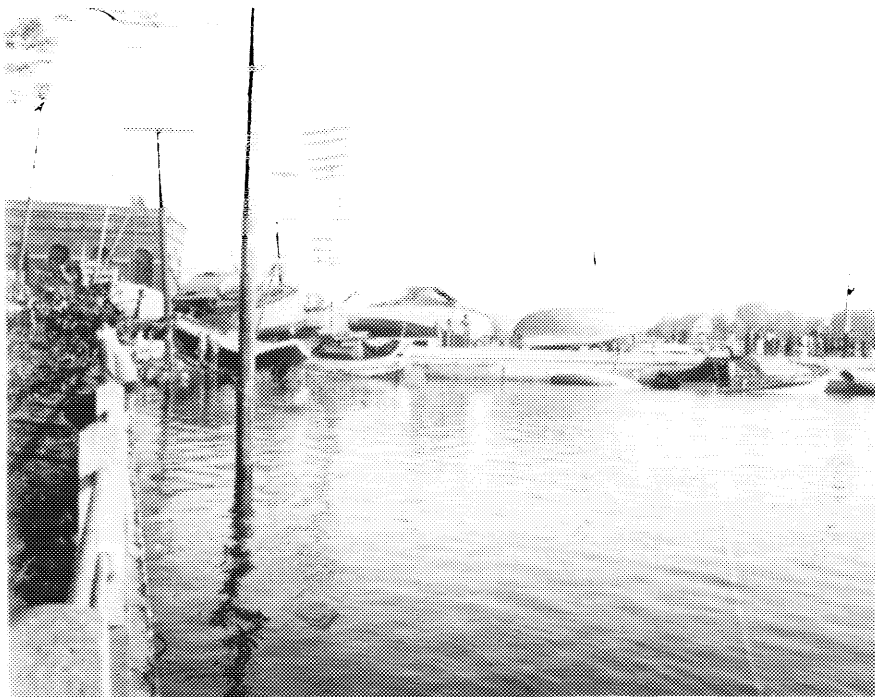
BARRINGTON, R. I. Pleasure craft piled up at
bridge over Barrington River.

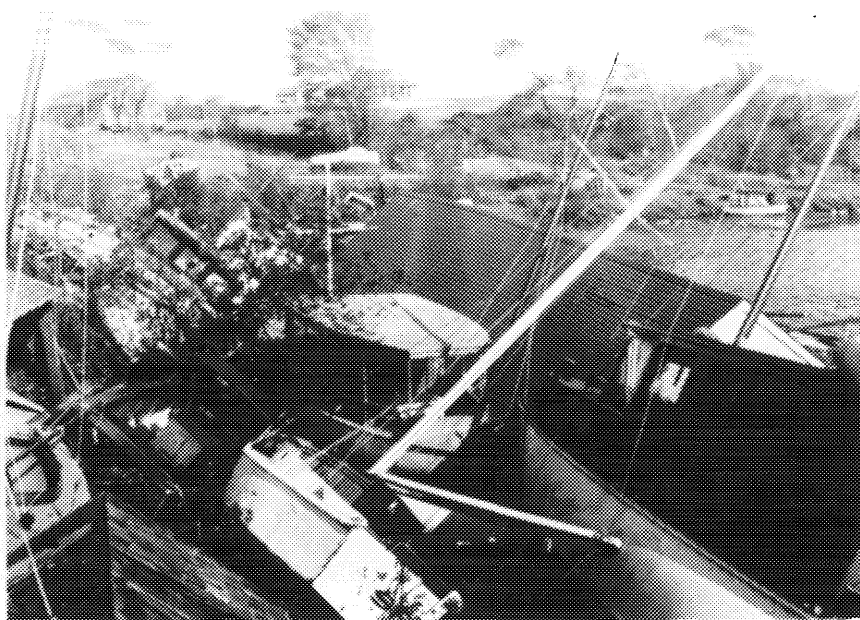
WAKEFIELD, R. I. Yachts cast ashore and piled
behind building.

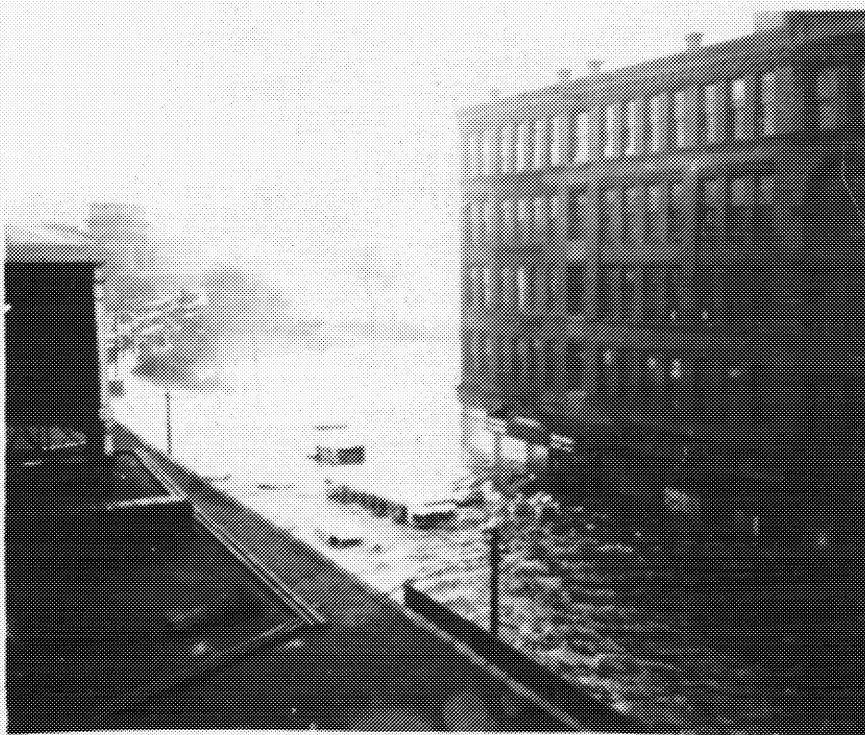
PROVIDENCE, R. I. Bus, trucks and buildings flooded on Fountain Street. Railroad station in background on left.

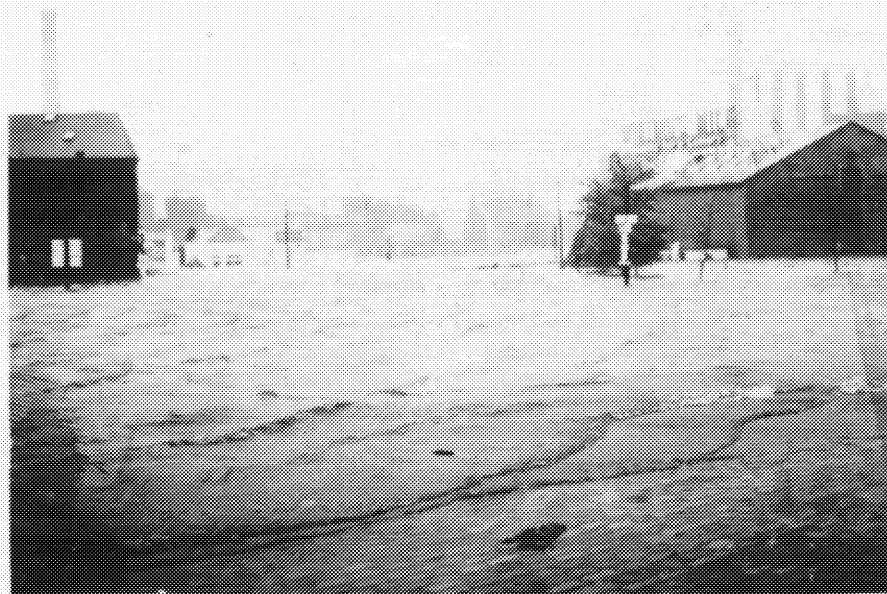
PROVIDENCE, R. I. Easterly approach to Point Street bridge flooded.

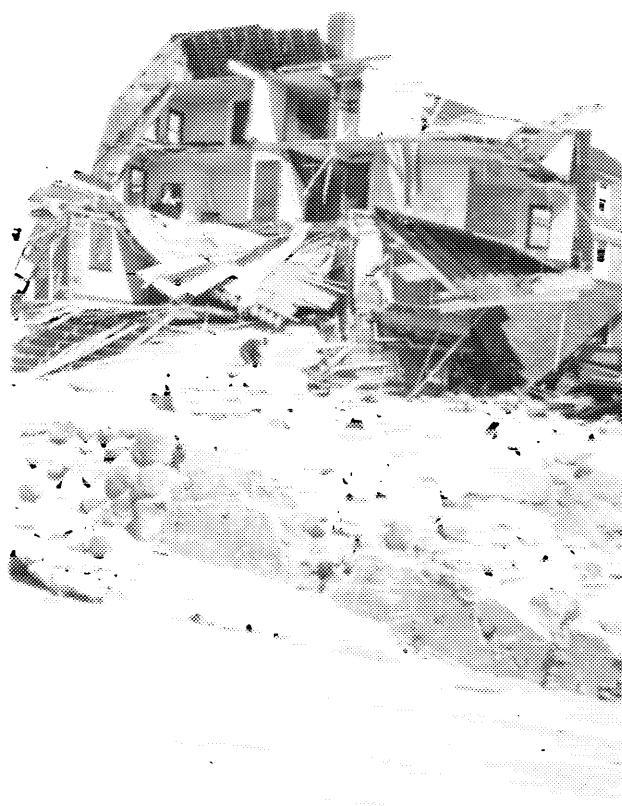
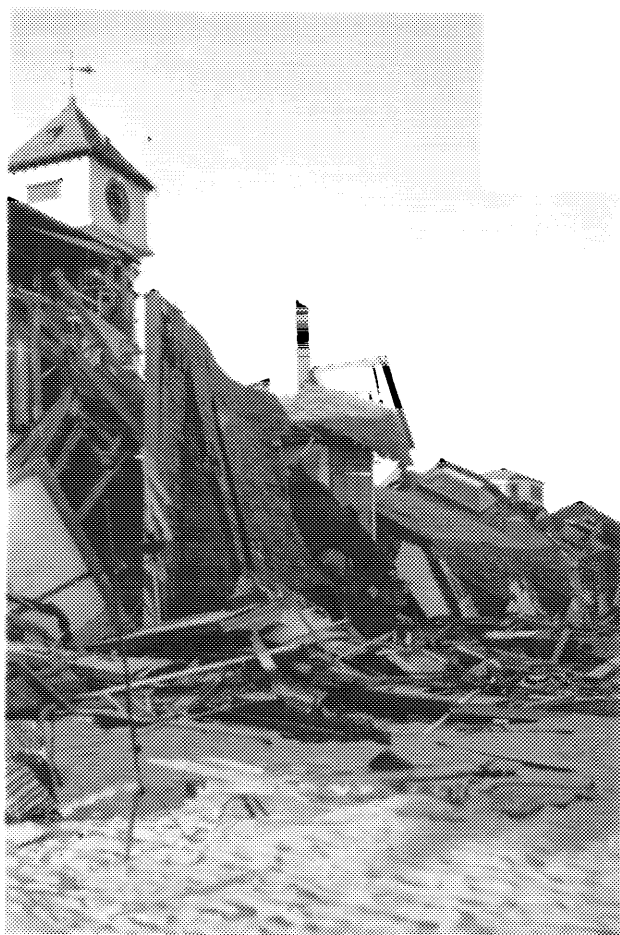
NARRAGANSETT PIER, R. I.
Ruins of Dunes Club.

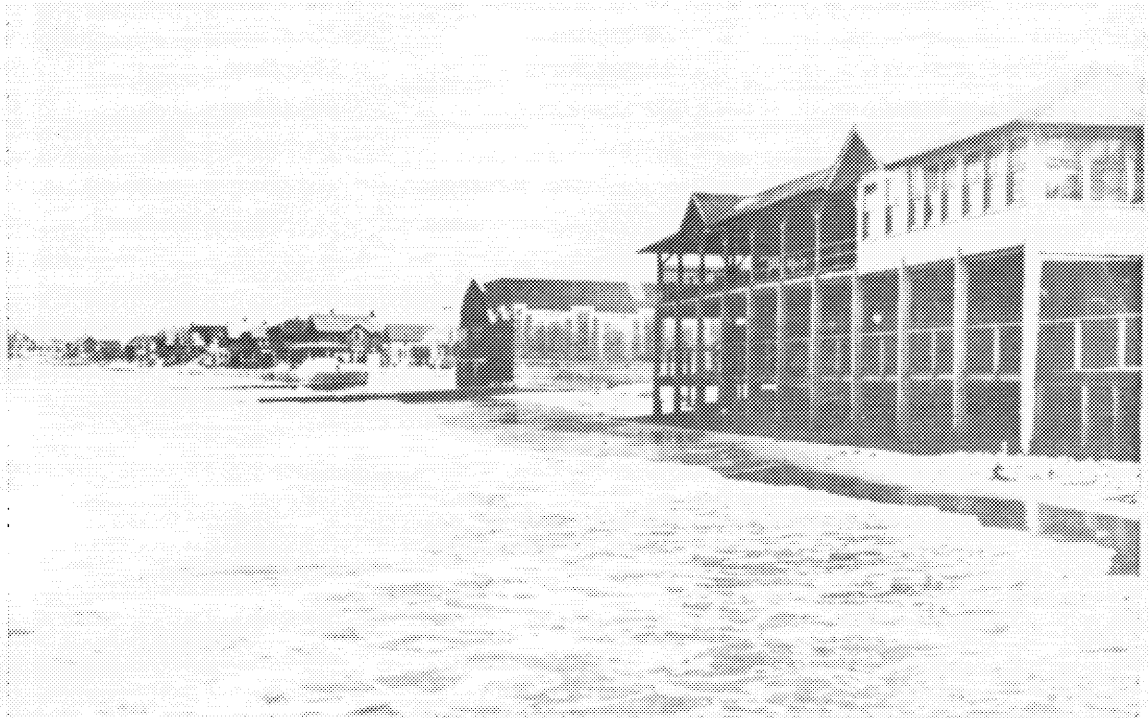
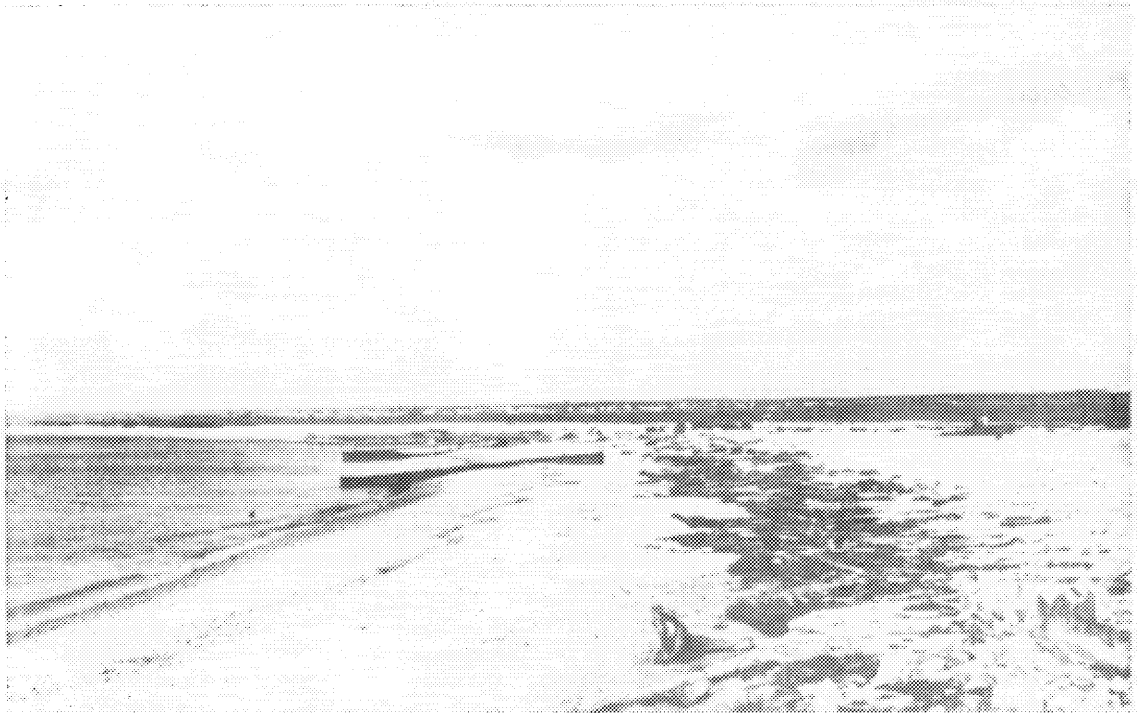
BEFORE HURRICANE

AFTER HURRICANE

WATCH HILL, WESTERLY, R. I.
Looking westward along Napatree Beach. Note wooden groins which survived.

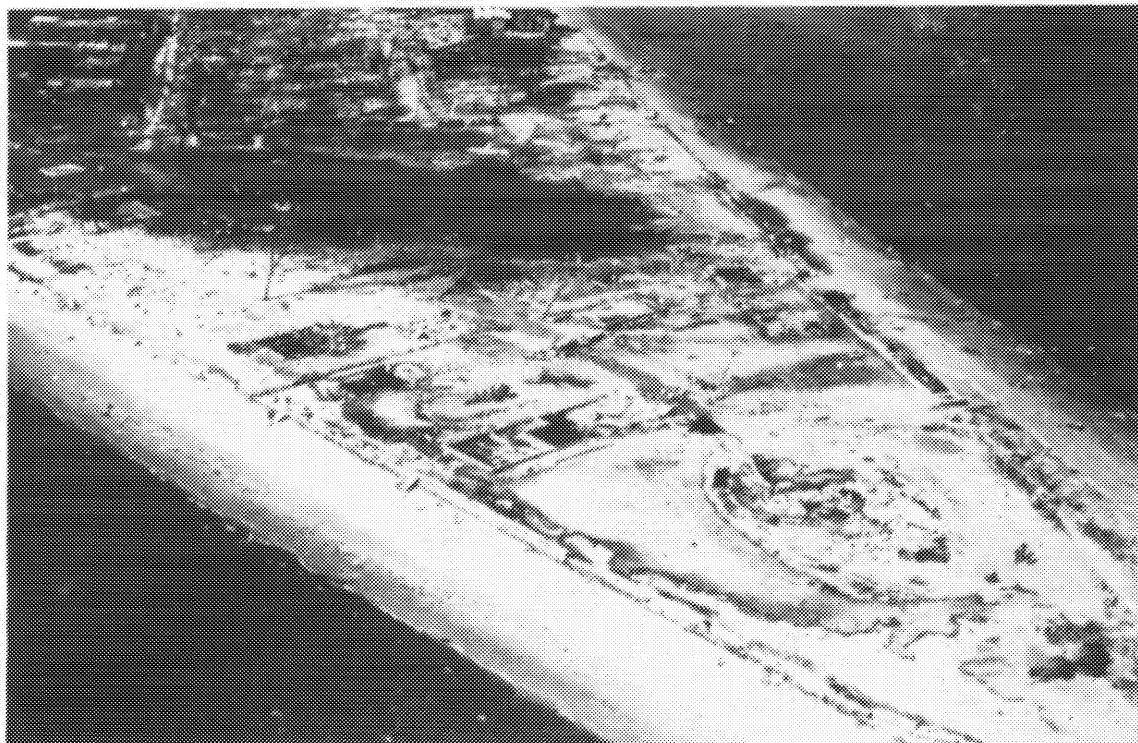
CONIMICUT POINT, WARWICK, R. I.

Many dwellings were swept off this foreland; foundations only remain.

44. Warwick, Rhode Island. - The bluff at the rear of Gaspee Point, a cusped bar, was reported cut back about 10 or 12 feet. The shore line and beach at Conimicut Point probably changed little. Practically all buildings on this foreland were demolished or badly damaged. Erosion on Warwick Neck is shown on Plate 4. Erosion was evident on the beaches along the north side of Greenwich Bay.
